TECHNICAL REPORT NO. 360

**The Installation of a Digital Autoguider and Tiger Counters in
Narrabri in 2013 April**

Steven J. Hale and Guy R. Davies

2013 May 20

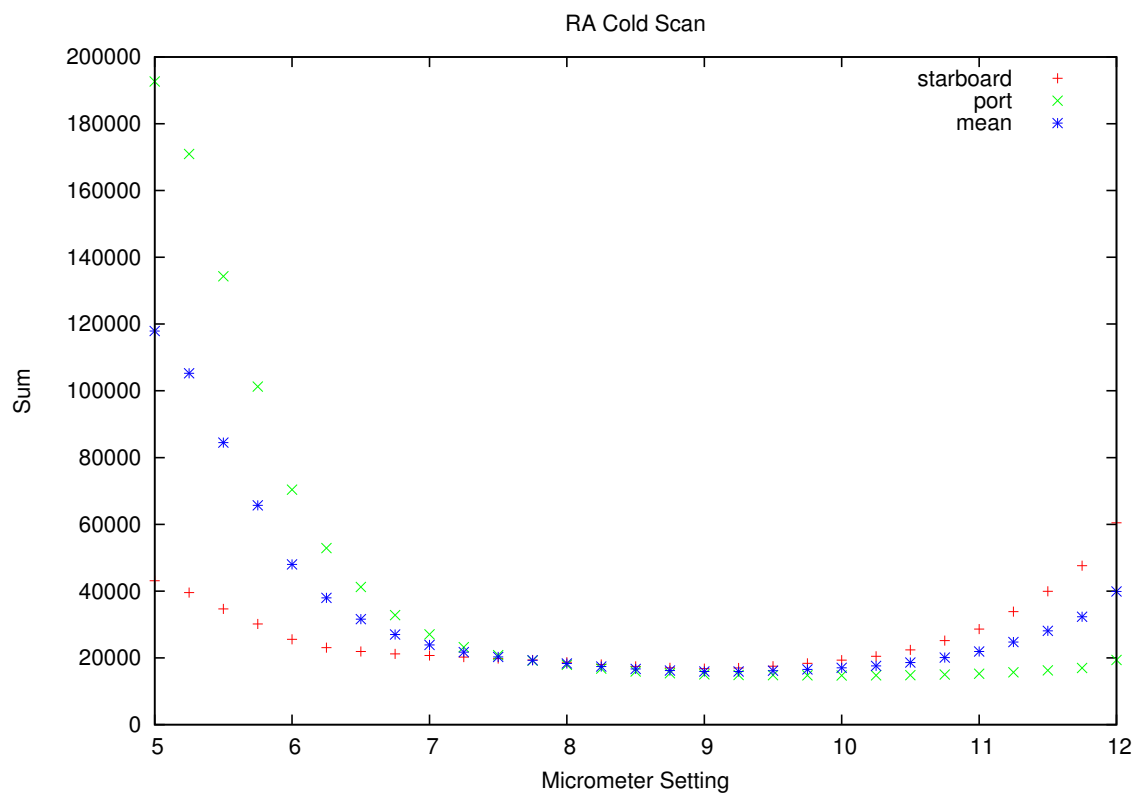
Figure 1: RA Cold.

Four autoguider scans were performed. Both axes were scanned with the potassium cell cold, and then again with the cell hot. The results from the cold scan are shown in figures 1 and 2. The results from the hot scan are shown in figures 3 and 4.

Initially the RA micrometer was set to 9.1 mm and the Dec micrometer set to 8.5 mm. The scans show the ideal alignment to be at RA 9.0 mm and Dec 8.5 mm.

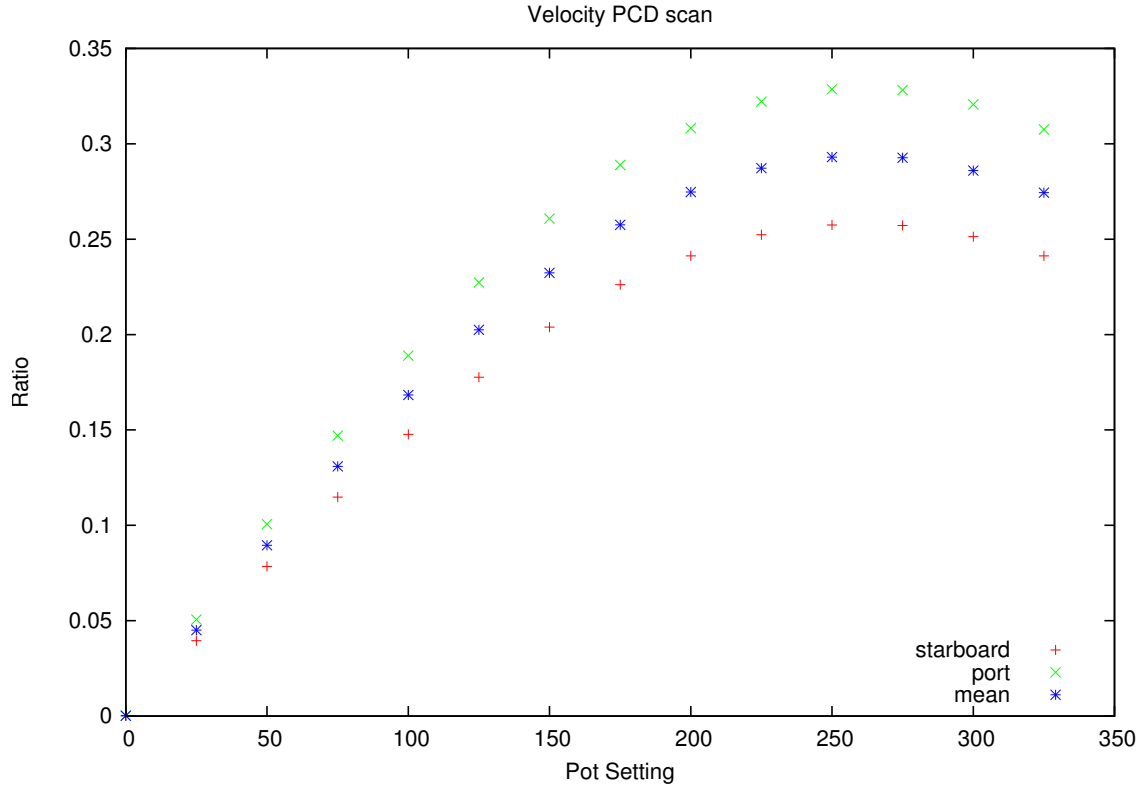
Figure 5: Velocity PCD scan.

The delta-B was disconnected and the magnetic Pockels cell removed. The driver was scanned over the full range while looking at the velocity ratio output from the detectors. The results are in figure 5. The initial setting was “230”, the new scan suggests the best setting is “260” and so the velocity driver was adjusted to the new optimum.

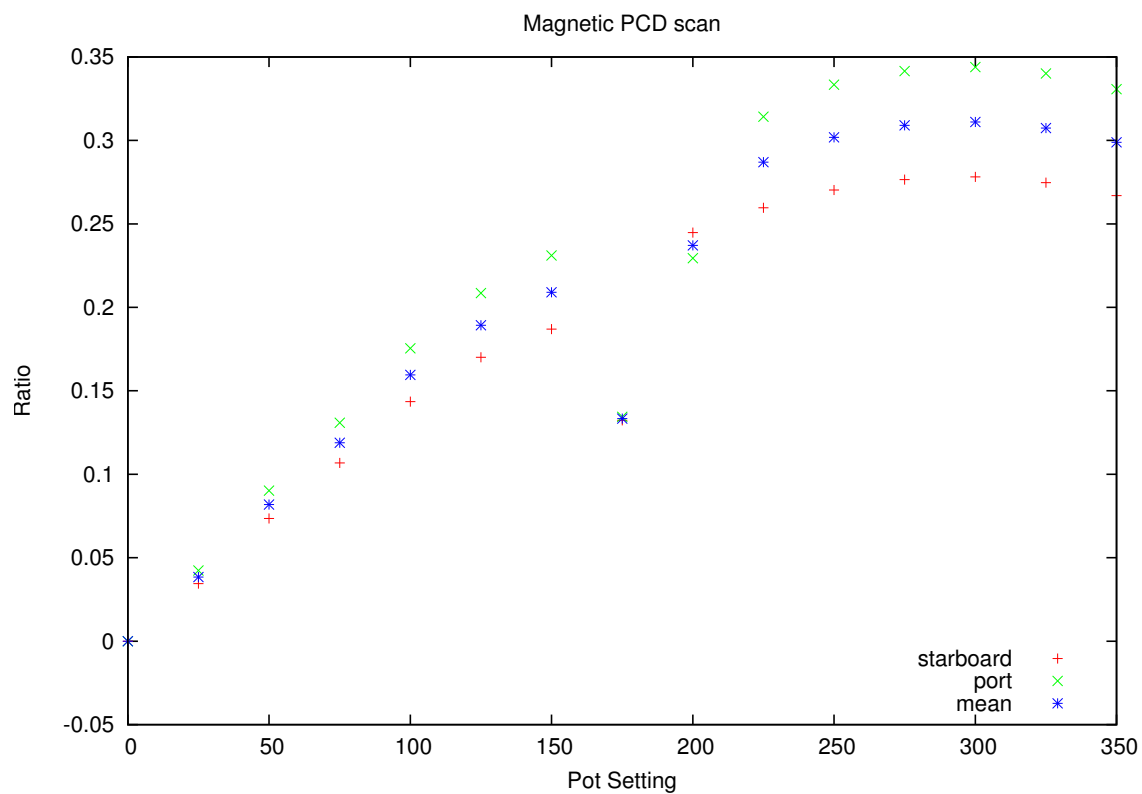
Figure 6: Magnetic PCD scan.

Calibrating the magnetic Pockels cell is slightly more tricky. The magnetic Pockels cell was replaced, and the velocity Pockels cell removed. The magnetic Pockels cell was then moved behind the polariser into the velocity position. The scan was then repeated using the magnetic cell and driver. The results are in figure 6. The initial setting was “250”, the new scan suggests the best setting is “300” and so the magnetic driver was adjusted to the new optimum.

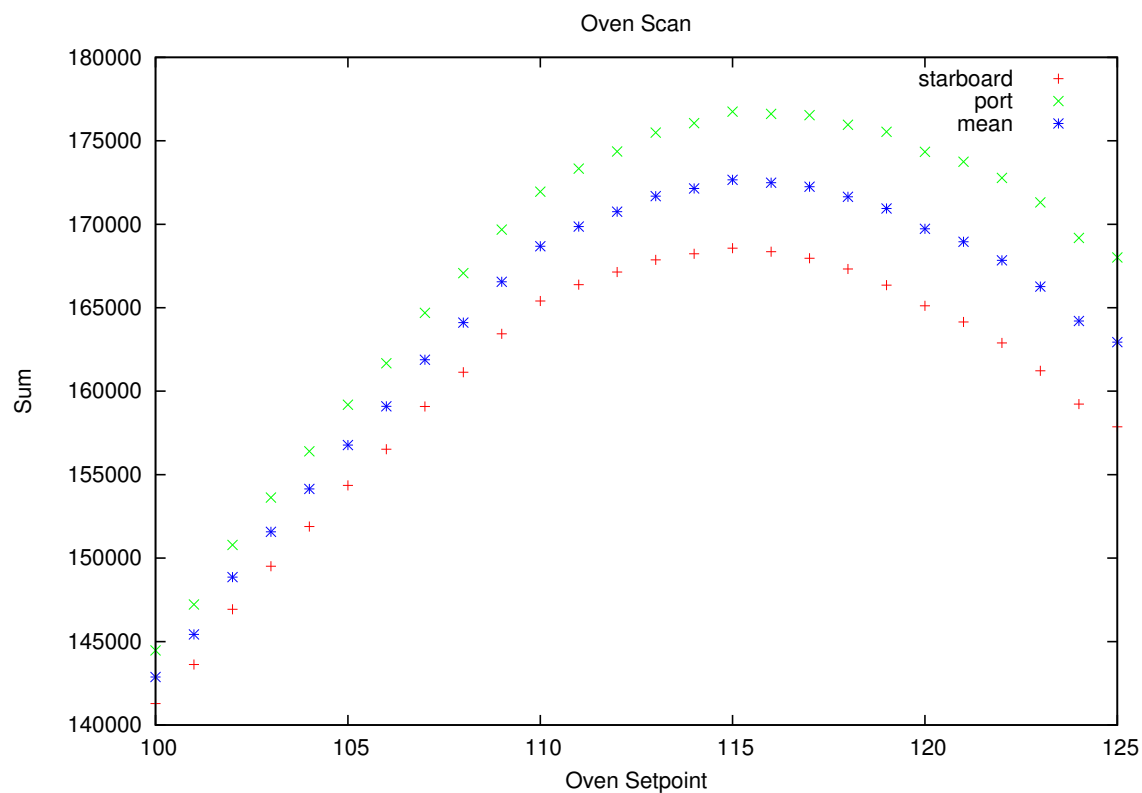
Figure 7: Oven Temperature Scan

The potassium cell was slowly scanned over a range of temperatures. The results are in figure 7. Initially the oven was set to 113 C. The temperature scan shows 115.5 C to be correct, and so the temperature setpoint was updated.
